**CONDITION ASSESSMENT OF
MELROSE PRIMARY SCHOOL**

**THE DEPARTMENT OF EDUCATION
AND TRAINING
FACILITIES MANAGEMENT**

PERFORMED JUNE 2004

**BY DEPARTMENT OF URBAN SERVICES,
CITY OPERATIONS,
FACILITIES MANAGEMENT**

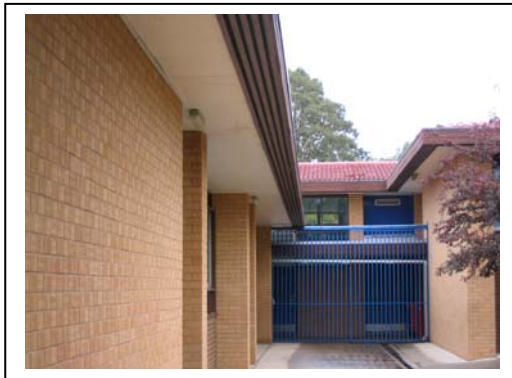
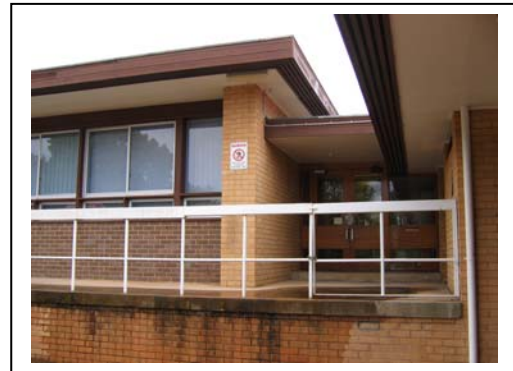
21.1	BUILDINGS	IDENTIFIED ASBESTOS	External toilet adjacent Library	The damaged manhole cover contains Asbestos - Replace		2	B		300					300
21.1	BUILDINGS	IDENTIFIED ASBESTOS	All perimeter eaves	Eave sheeting contains Chrysotile Asbestos. It is not envisaged that removal will be required during the currency of this condition assessment		4	D							0

Above left and above: perimeter asbestos cement eave soffit sheet

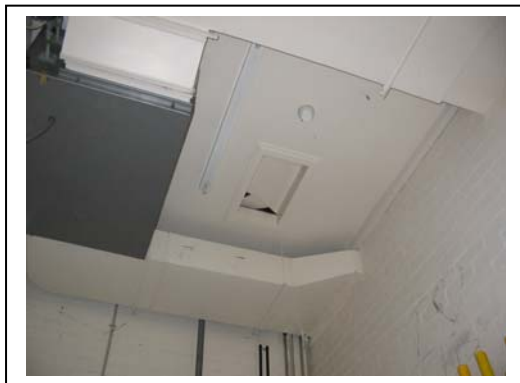
Left: manhole cover – damaged asbestos sheeting
